The Target, acoustic chamber with measuring bar, is the main part of the SIUS electronic scoring system. Lack of sufficient and expert maintenance cannot be compensated not even by the most efficient scoring electronic.

This information is to be considered as an addition to our existing Installation, User- and Maintenance Manual. It is important to maintain the system according to the direction provided by this manual.

Target Maintenance

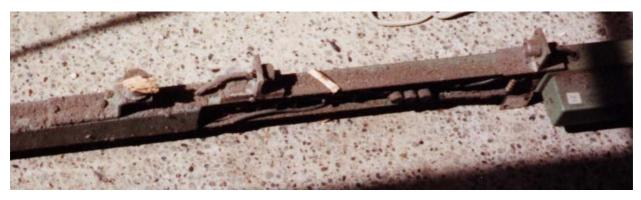
A measuring bar as shown in the following is **not** in the position to provide correct results due to the dirt on the acoustical transducers.

Any dirt must be removed regularly from the measuring bar. For further procedure see the maintenance manual.

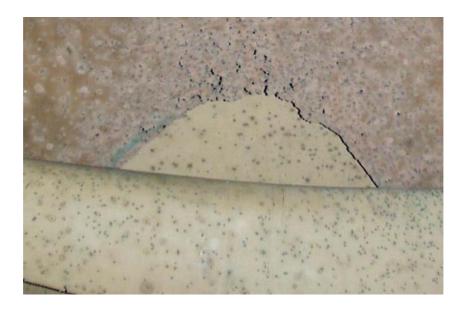
With these shots fired the additional cut out needs to be foreseen.

The additional cut out is made with a scissors to make sure that no scraps of the rubber skin rise up into the acoustic chamber.

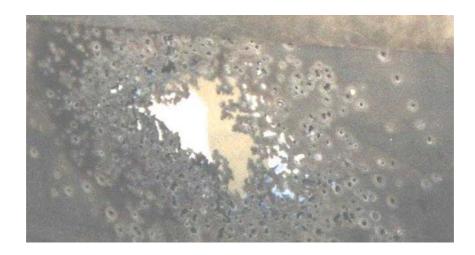
At this stage the additional cut out **must** be made.

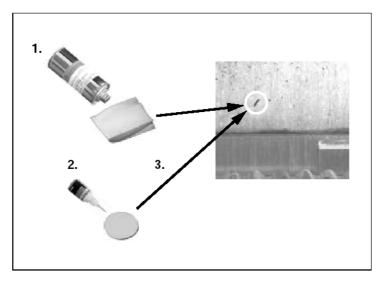
Any holes in the rubber skin above or below the endless rubber band must be covered immediately to prevent strange noise from entering into the acoustic chamber. Holes going through the endless rubber band and the main frame can be covered by moving forward the endless rubber band.

Holes in the rubber skin of the main frame influence the accuracy of the target extremely!

- 1. Clean the damaged spot with acetone
- 2. Apply special glue CA15 G on patch
- 3. Press patch immediately on the damaged spot

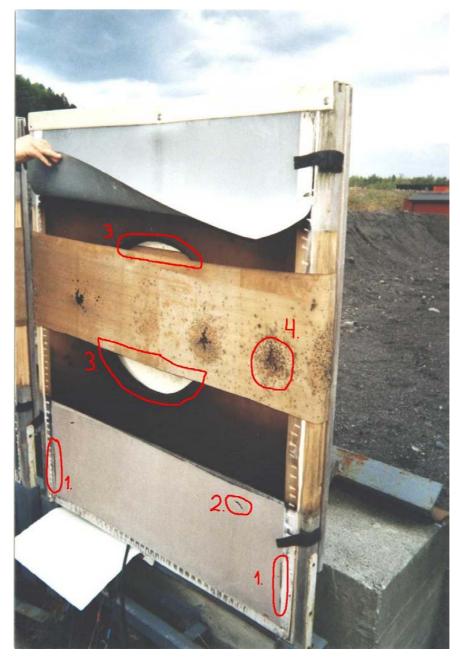
Never use targets in this condition!

- 1. The lower part of the rubber skin is already weathered heavily. The rubber skin is torn at the level of the acoustical transducers.
- 2. There are ricochet holes.
- 3. The endless rubber band does not fit the cut out of the main frame (too small).
- 4. The holes in the rubber band should have been avoided by moving forward the endless rubber band more often.

This picture has been taken in a shooting range where the user claimed that shots are not displayed accurately or not registered at all.
